Mazda *Tips*

July

Timely Repair Information for Mazda Dealer Service Personnel

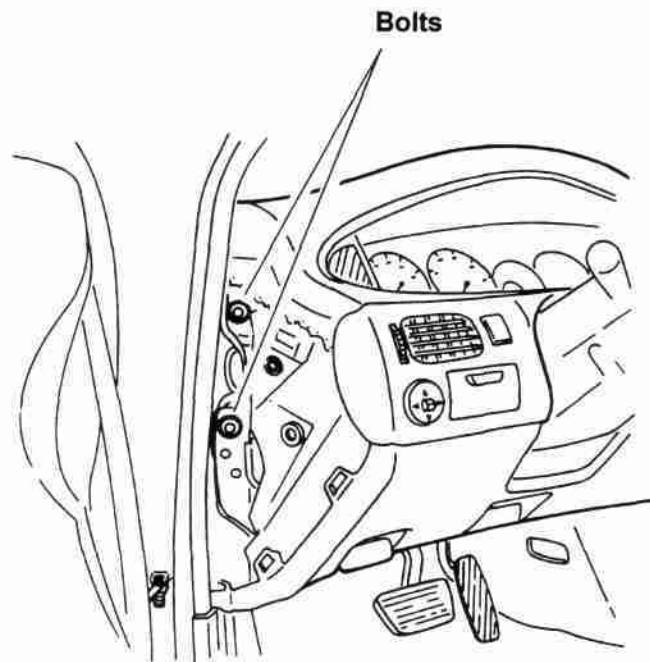
Rattle From Left Side of Dash ('93 - '97 626)

A rattle noise coming from the left side of the dash may be heard when going over bumps or rough road surfaces. This may be caused by loose or cross threaded instrument panel attaching bolts. Inspect, and if necessary repair the concern according to the following procedure.

1. Remove the left dash side cover.
2. Check the left side instrument attaching bolts for proper torque (113-148 In./lb).

Note: If the bolts are cross threaded, remove and discard the bolts, repair the threads, and install new bolts.

3. Reinstall the side cover and verify the repair.

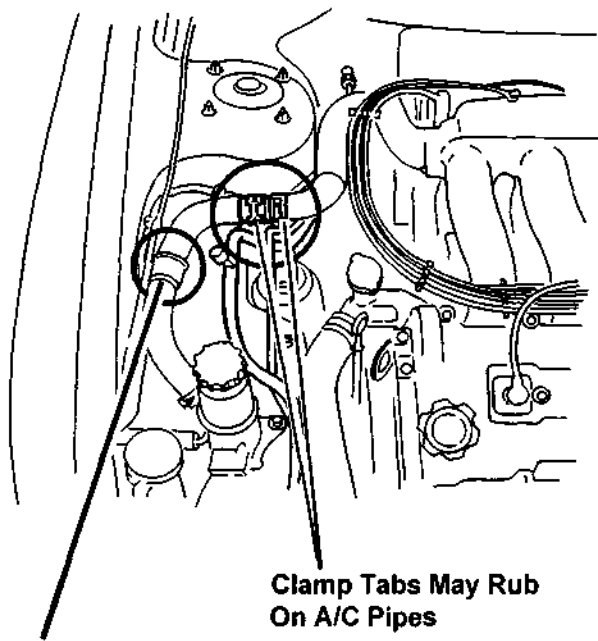
Location of Tie Wrap

Rattle Noise-P/S Hose Clamps Rub On A/C Pipe ('93 - '97 626 V-6)

A rattle noise coming from the engine compartment may be caused by the tabs of the power steering pump return hose clamps rubbing on the high or low side A/C pipes.

- * If no extensive damage is done to either A/C pipe, rotate the hose clamps to allow enough clearance between the clamp tabs and the A/C pipes.
- * If either pipe has extensive damage, replace the damaged pipe(s) and rotate the hose clamps to allow enough clearance between the clamp tabs and the A/C pipes.

Also tighten the tie wrap that holds the high and low pressure power steering hoses together.
